# Condition Assessment Report

Portsmouth Civic Center Complex

April 29, 2019  
CN# 8305

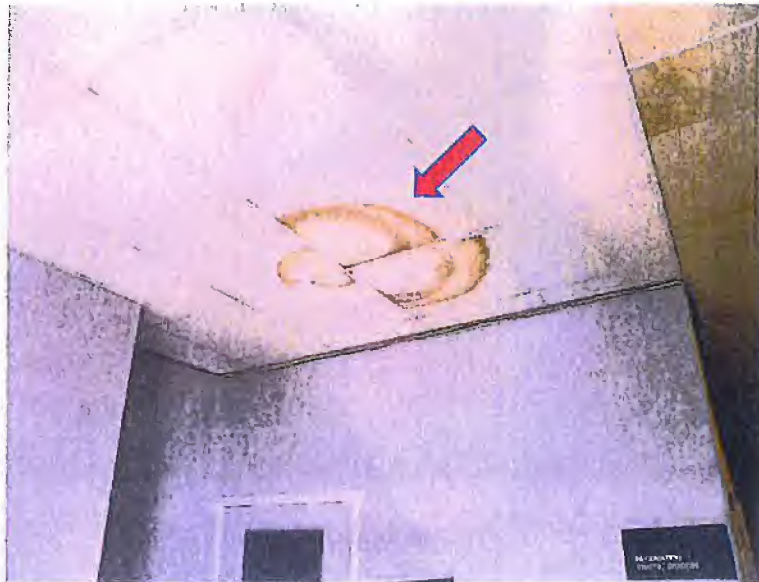
Photo -HQ1

It is apparent that the roof, exterior walls and windows leak badly. See photos HQ-1 through HQ-14. Although it may not be obvious, the center area ceiling in some areas has fallen or sunken approximately 6" below the adjacent ceiling areas. See photo HQ-8. Water leaks in the basement area Police Evidence storage spaces show significant flooding over an extended length of time. See photos HQ-11, HQ-12, HQ-13 & HQ-14. Some of the exterior wall and window leaks can be attributed to the apparent use of non-water proof construction to fill a former window opening after a residential window style air conditioner was installed. See photo HQ-15.

- Replace and replace all existing roofing and flashing.
- Remove residential window mounted air-conditioning unit. Provide a commercial equivalent which does not have to be window mounted. Remove plywood closure. Replace all windows with thermally broken window systems and energy efficient glazing.
- Provide code compliant vapor and thermal barrier systems at all exterior surfaces.
- Demolish all existing water damaged interior partitions/ finishes and replace with new to suit current use.
- Inspect all exterior precast concrete elements and replace damaged sections and/or attachments.
- Replace previously removed precast concrete elements to match existing.
- Renovate existing elevator systems.

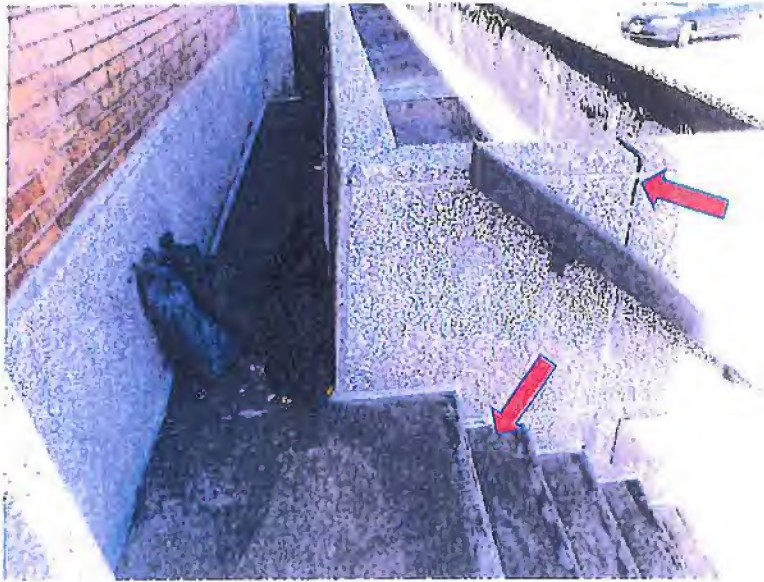
Photo -PL1

All construction appears to be original to the complex with only minor maintenance consisting primarily of sealant at joints between the precast concrete panels. This sealant appears to have exceeded its useful life span and is failing. See photo PL-1

- Remove all precast concrete pediment wall and paver panels. Remove and replace all existing waterproofing. Provide new precast concrete pediment wall and paver panels to match existing.
- Remove and replace all water proofing in planters.
- Repair and/or replace existing plaza level and planter drainage piping as required to provide proper operation.

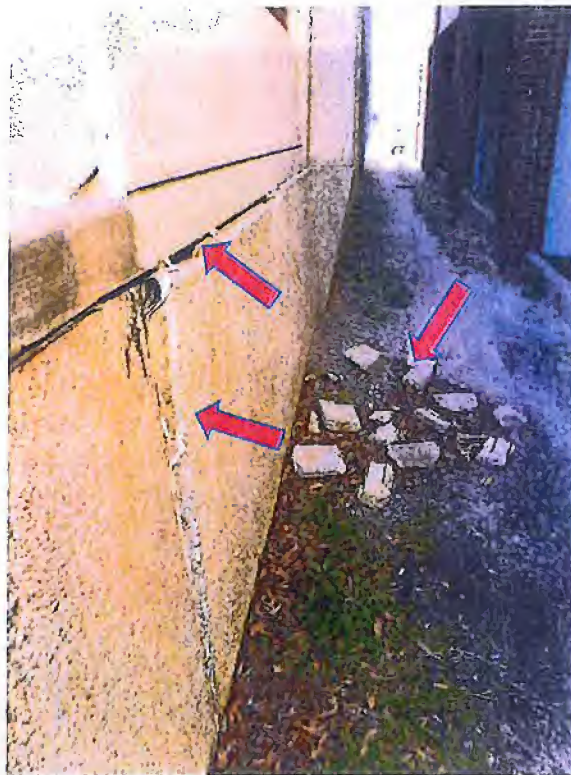
Photo -PL2

Based on evidence of significant water leaks at the Basement Level of the complex it appears the original waterproofing under the perimeter precast concrete walls and walkway panels have failed and, in some areas, precast panel steel anchors have become exposed and are rusting which has allowed precast concrete elements to loosen and, in several locations, fall off the building. See photos, PL-2, PL-3, PL-4, PL-5, PL-6 & PL-7

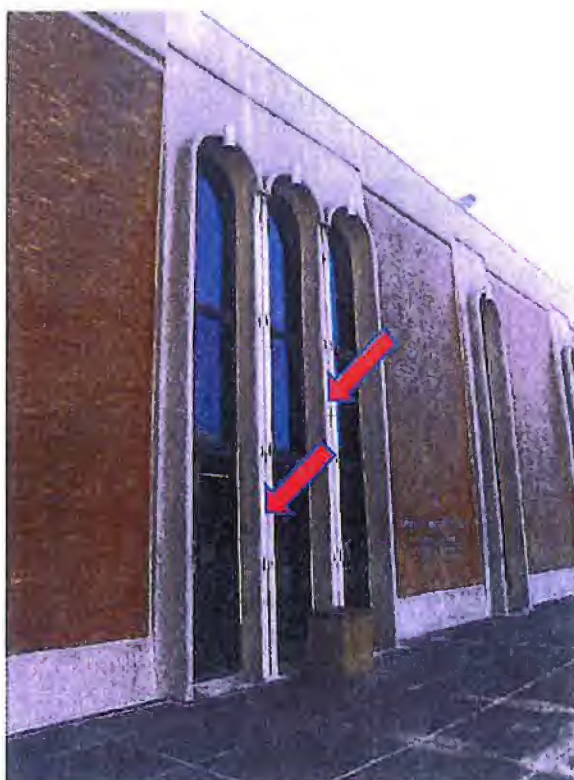
Photo -PL8

The plaza level drainage system is not functioning properly. This is evident by the fact it had not rained in several days prior to our field investigation and standing water was visible in several locations. This is undoubtedly contributing to the basement level leaks. See photos PL-8 & PL-9.

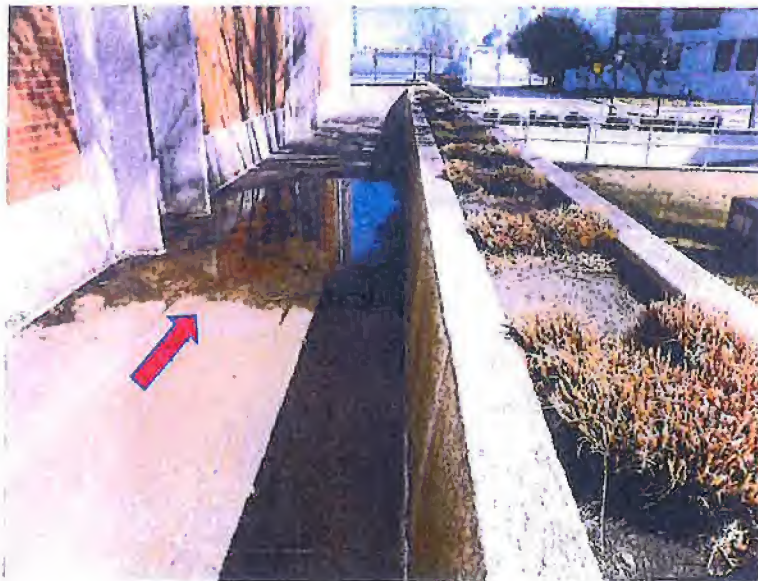
Photo -PL10

As previously noted, the perimeter of the plaza level is lined with precast concrete planer boxes. These planter boxes have a water proofing membrane and internal drains. A few contain soil and plantings but most are empty, except for trash and the water proofing membrane is exposed and obviously failing. One of the planter boxes is filled with water. See photos PL-10 & PL-11.

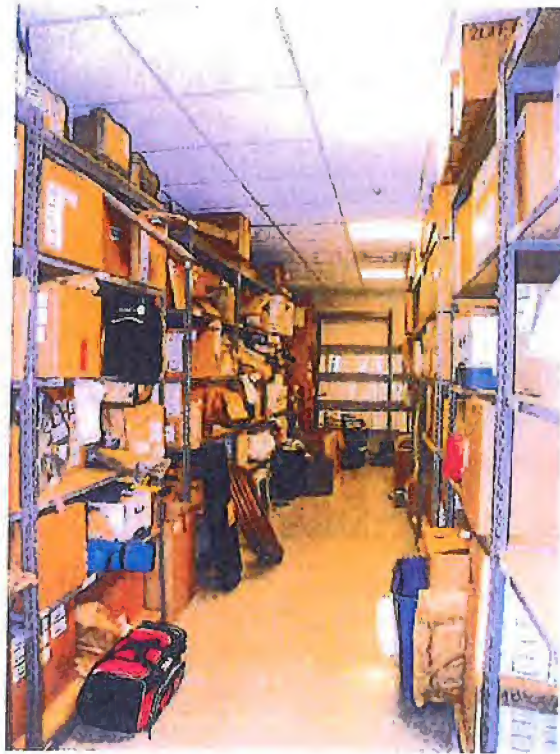
Photo -JB1

The Police Department Property and Evidence Storage and City File Storage areas are in good condition given the fact both areas were renovated during the past few years. Although the building was not designed for storage, the Police Department has optimized the use of the space. See photo JB-1.

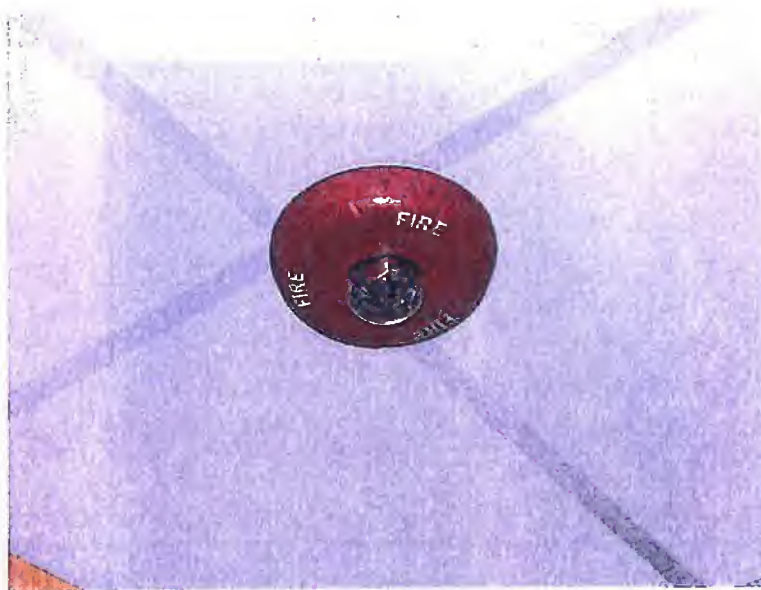
Photo -JB4

Some new fire alarm notification devices were noted, but the coverage does not appear to fully meet the requirements of NFPA 72 or the Americans with Disabilities Act. See photo JB-4.

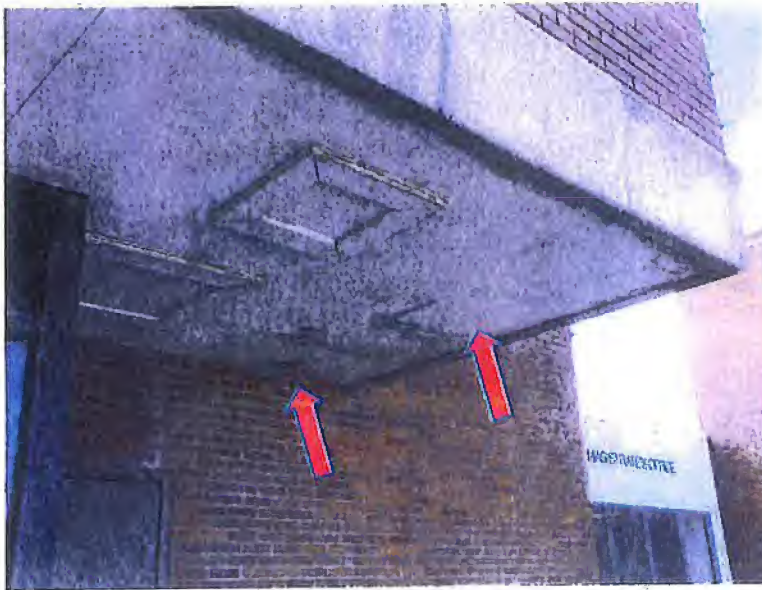
Photo -J3

The exterior brick and precast concrete elements of the jail appear to be in good and serviceable condition but after further investigation appears to be holding a significant amount of water. Although, it was well above freezing during our field investigation a large ice formation had grown down from the Jail tower. See photo J-1. Excessive water under the brick is also evident by extensive efflorescence on the east side of the building. See photo J-2. Extensive finish discoloration and water stains are also visible on several of the plaza level soffits. See photos J-3 & J-4.

- Remove and replace all existing roofing and flashing.
- Investigate water within the exterior masonry cavity and replace existing flashing and waterproofing as required.

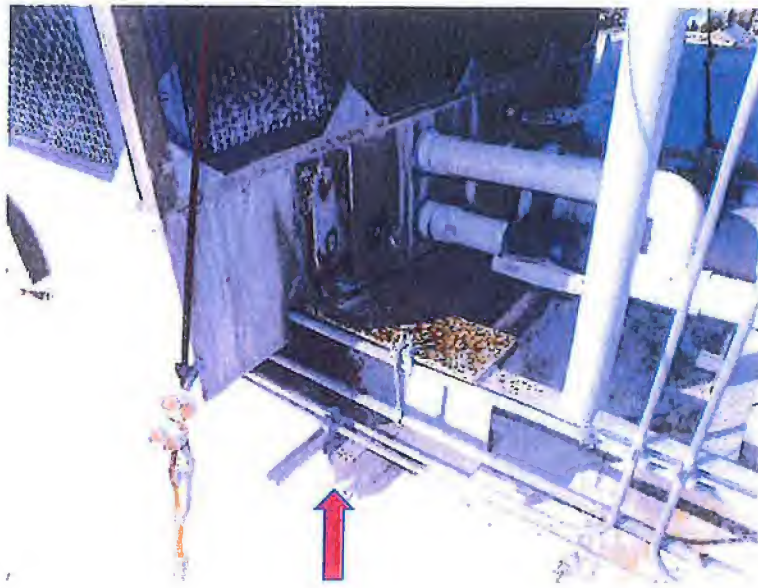
Photo -J5

On the roof there appears to be a relatively new white membrane roof. The details used to seal the mechanical equipment curbs are no longer water tight. See photo J-5. The original design included a pair of mechanical equipment screens and their removal has left openings in the brick which are not water tight. See photo J-6. The roof access door and frame are significantly rusted to the point they are rusted shut and can not be easily opened. See photo J-7.

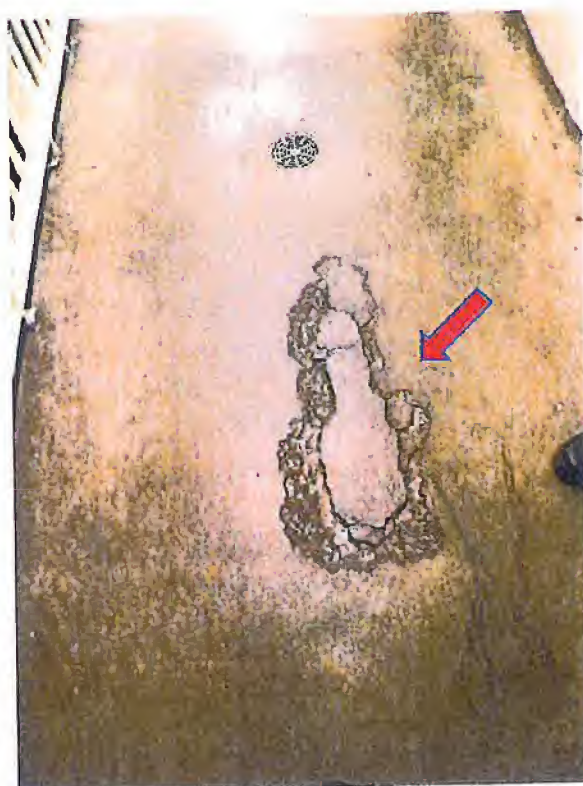
Photo -J16

In several basement areas the floor slabs are showing signs of significant deterioration, most likely from standing water from an adjacent floor drain. See photo J-16.

- Repair and/or replace as required all existing reinforced masonry concrete construction damaged by water.
- Inspect all exterior precast concrete elements and replace damaged sections and/or attachments. Replace previously removed precast concrete elements to match existing.

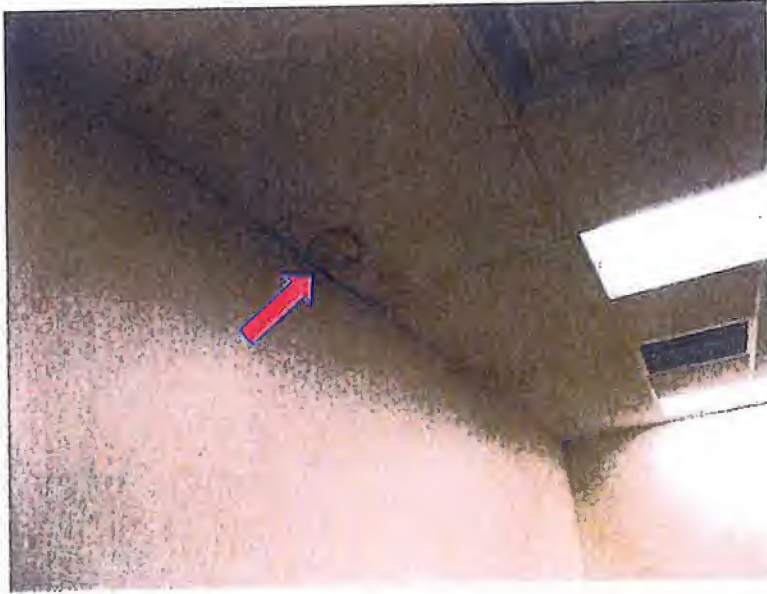
Photo -M1

There is evidence of roof leaks where the addition abuts the two existing Judicial buildings. See photo M-1.

- Repair and/or replace existing roof flashing where addition ties into the pre-existing Judicial buildings.
- Replace all water damaged interior finishes.

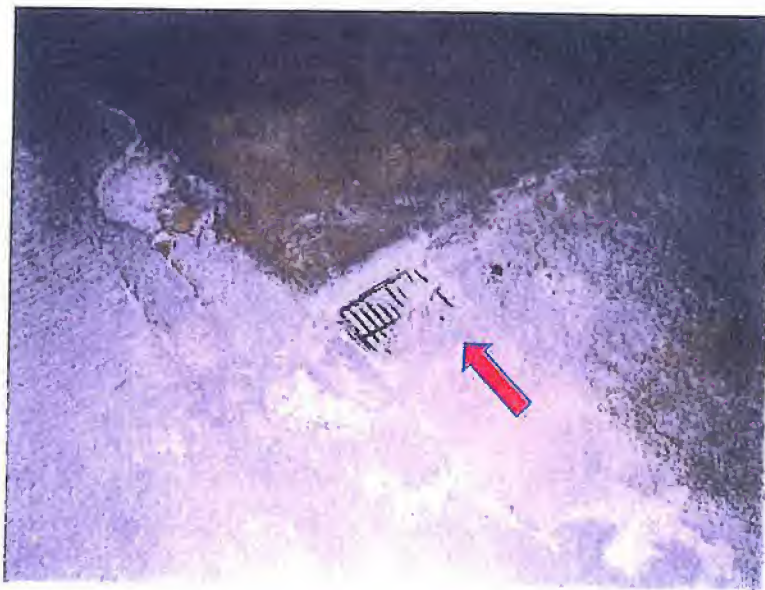
Photo -G2

Due in part to the 24-hour per day, 7-day a week operation of the Portsmouth Police Department, the Police basement parking area floor is subjected to significant wear from Police and Sheriff department vehicle traffic loading on the basement floor pavement. Some of the concrete slabs have been repaired. See photo G-1. As these concrete slabs continue to wear, concrete debris covers the floor slabs and this debris has filled and clogged the floor drains to the point they no longer function. See photo G-2.

- Repair and/or replace existing reinforced masonry concrete construction damaged by water.
- Repair all fire rated construction.
- Replace all existing water damaged interior partitions/ finishes.
- Repair and/or replace existing drainage piping as required to provide proper operation.

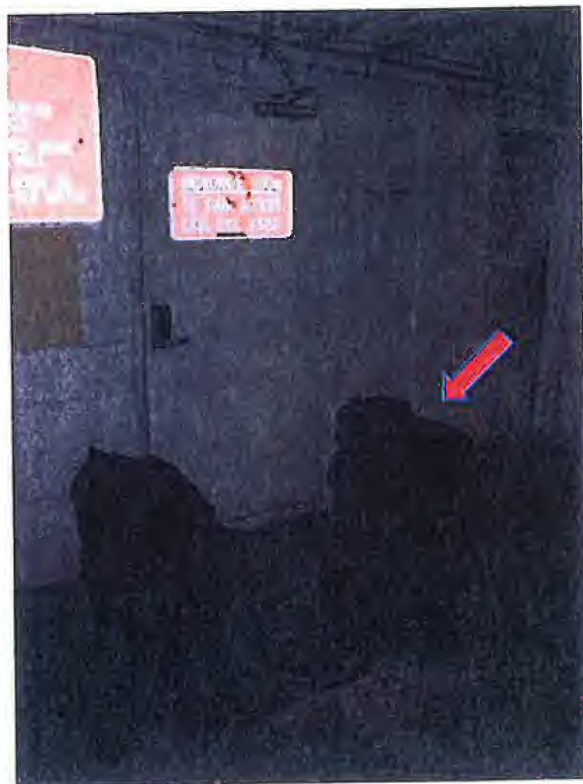
Photo -G8

Many of the issues noted in the Police Basement are also evident in the Courts Basement. Long term uncontrolled running and standing water also threatens critical city infrastructure. See photos G-8, G-9 & G-10.

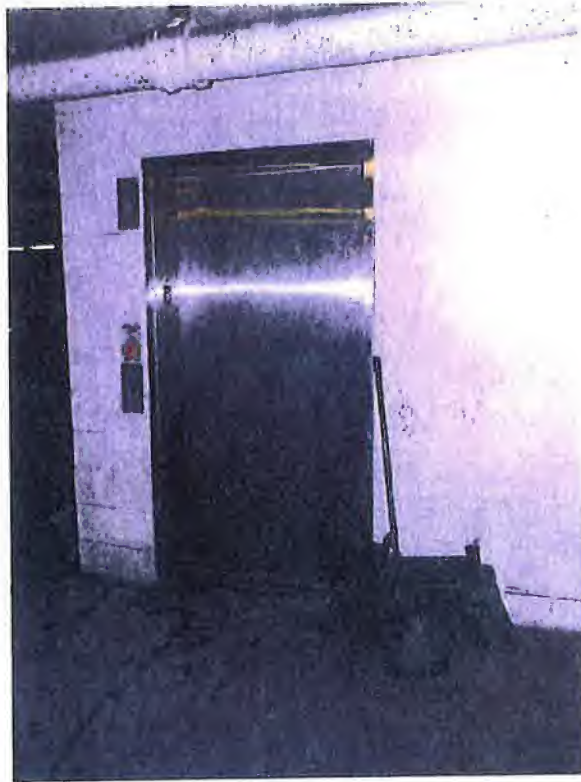
Photo -G11

It was noted that the only in-service elevator from the Courts Basement up to Police Evidence Storage had recently failed an elevator inspection, however, the elevator was still in operation and parts had been ordered. See photo G-11.

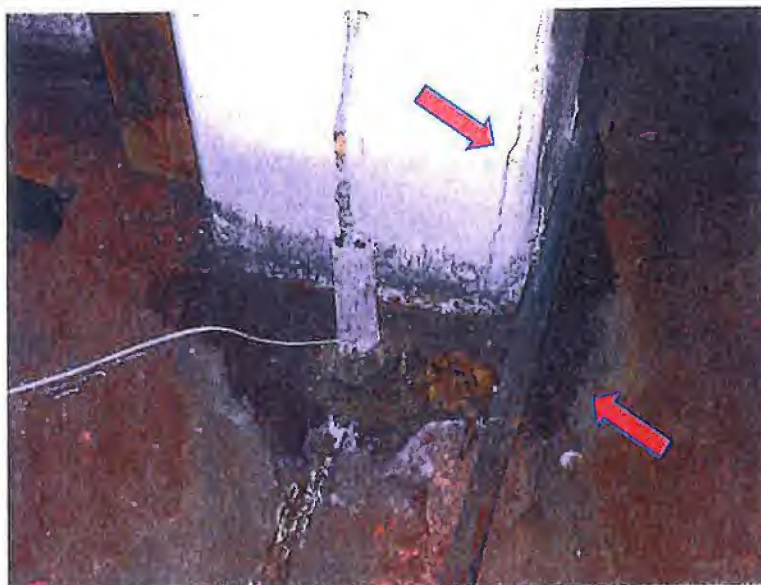
Photo -G16

Although small, possibly the most serious issue detected while touring this area was standing water at the base of a building column and a crack in the column, as there was no apparent evidence of something striking the column to cause the damage. The most likely cause of the crack is prolonged exposure to water seeping into the concrete and caused the reinforcing steel to rust and deteriorate. Typically, when this happens the steel swells as it corrodes and has apparently cracked the concrete. See photo G-16.

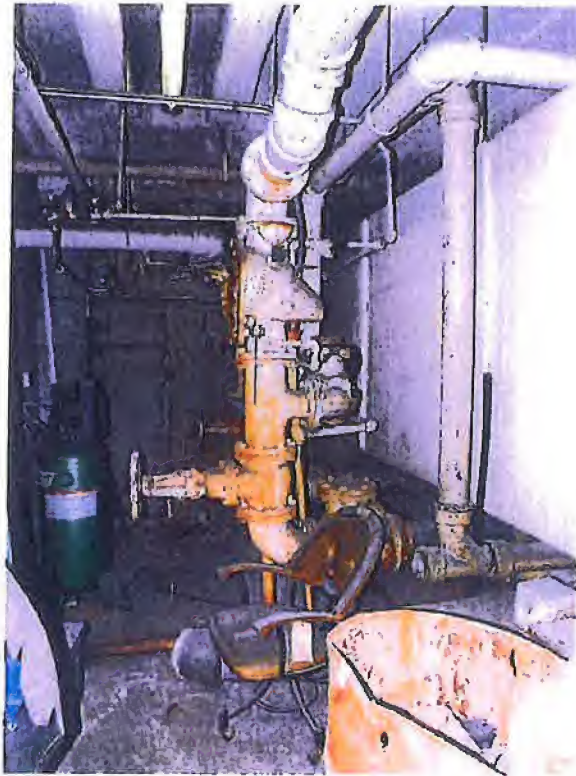
Photo -G17

The garage is provided with two dry pipe sprinklers, although the systems are currently tagged “out of service.” See photos G-17 and G-18. The piping shows signs of exterior corrosion, and the internal condition of the piping is unknown. See photo G-19. The sprinkler heads also show some signs of surface corrosion, so it is possible that they won’t activate properly in the event of a fire. NFPA has requirements for periodic testing of sprinkler heads, with a more frequent interval for sprinkler heads subject to harsher environments.

- Replace the sprinkler systems in their entirety, including all piping, valves and sprinkler heads.
- Extend fire alarm notification throughout the parking areas.
